## Biophysical Characterization of Mima Model Water Shade of the Benishangul Gumuz Regional State, Ethiopia: A baseline Tool for Planning, Implementation, and Evaluation

The Mima water shade covers an area of 1031hactar and the Mima water shade is one of the main streams draining into Afa River. The water shade is found at the distance of 24kms from Assosa town on the way to Addis Ababa through Bambasi District of Benishangul Gumuz Regional State. Baseline data was collected for biophysical (vegetation) parameters. The baseline data collection is built around seven transects by the use of blocks of 10 m<sup>2</sup> in size. Hence, in each block the sampling size is 54 plots. This baseline assessment presents the results of the data collected from the combination of field and on farm surveys in three blocks of the Mima water shade. Interpretation and management recommendations are based solely on the data and do represent a consensus view between the project and the survey results. It is imperative that before initiating any activities in the respective blocks, more information be collected for the targeted area chosen for interventions. The result of the evaluation showed that the

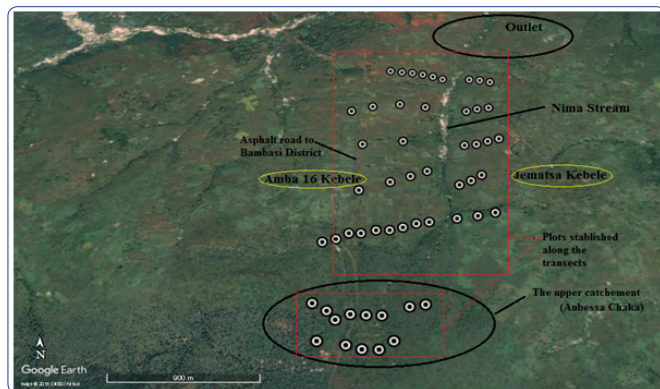
Figure 1: Map of Mima water shade

The Mima water shade covers an area of 1031hactar and the Mima water shade is one of the main streams draining into Afa River. The water shade is found at the distance of 24kms from Assosa town on the way to Addis Ababa through Bambasi District of Benishangul Gumuz Regional State. It is bordered by Amba 16 kebele to west and Jematsa kebele to east direction. Mima water shade is bounded by longitudes 34°39' east and latitudes 9°55' south. The central point of the water shade is transversed by Longitude 34°40' East and Latitude 9°56' S (Figure 1).

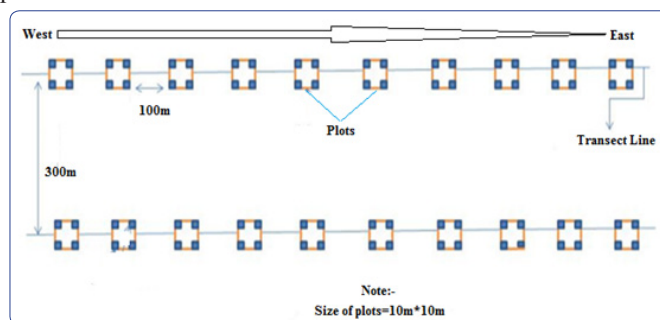
Figure 2: Schematic representation of transects laid and plots sampled

The baseline data collection is built around seven transects by the use of blocks of 10 m<sup>2</sup> in size. The basic sampling unit is called a plot. In each blocks, different points are generated from which 13, 16 and 25 sampling plots that constitute the cluster are generated. Hence, in each block the sampling size is 54 plots (see figure 2). The centre point of each cluster is randomly placed within each block. The sampling plots are then randomized around each cluster center point, resulting in a spatially stratified sampling design. This sampling design ensures proportional sampling within each block and minimizes local biases. The randomization procedures are done using either customized programs or scripts or a special Microsoft Excel spreadsheet that has been prepared for this purpose. Using these tools enables easy up-load of plot coordinates to GPS units, which are then used to navigate from sampling plot to sampling plot in the baseline data collection

Upon reaching the sampling plot, a square arm plot method is used in setting up the plot layout as described on figure 2. This method allows vegetation to be sampled and classified for an area of 1000m<sup>2</sup>. After identifying the points an additional vegetation data such as species habit and status was recorded. Once the plot layout is set-up, sampling can begin.

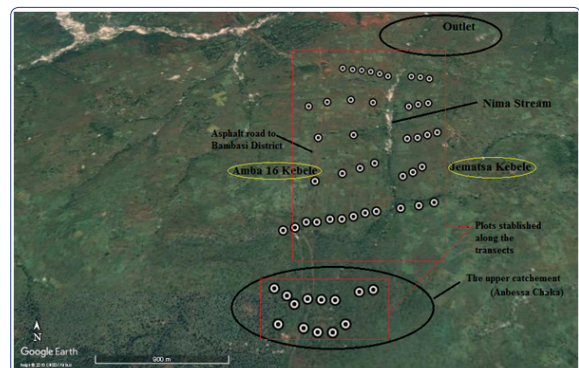
**Figure 1:** Aerial photograph showing Mima water shade and transects laid

The Middle block is located in both Jematsa and Amba 16 kebeles of Bambasi Districts. The block contains twenty-eight sub-locations (plots) as well as the Anbessa forest (Figure 1).

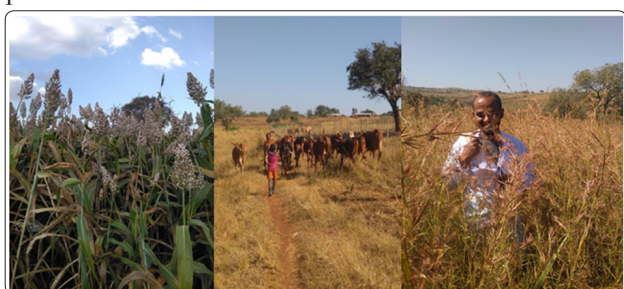
**Figure 3:** Some of common land uses in the eastern block (Jematsa Kebele)

The Mima stream borders the Jematsa block into the eastern parts. The northern part of the water shade (block) is characterized by better farming practices and fewer presences of trees in the landscape. The major food crop is sorghum. In this area all farms have hedges along the farm boundaries and more animals are seen to graze freely (Figure 3). The southern part of the block is characterized by poor farming practices with cultivation of steep slopes without conservation measures.

Farming is the major land-use and drives land cover in the eastern block (Jematsa Kebele) (Table 4; Figure 3). Agriculture is dominated by sorghum, soya beans, teff, and nug (*guzotia abyssinica*).

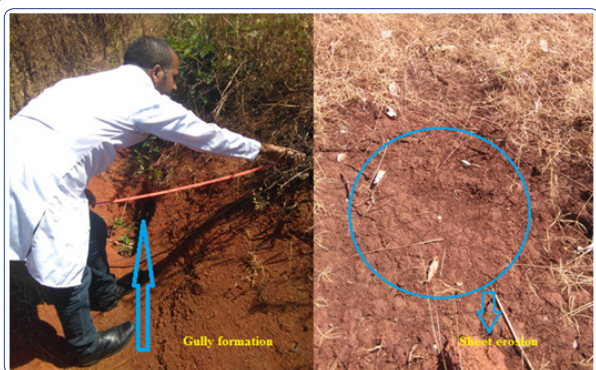
**Figure 4:** A plate showing a sign of soil erosion at eastern block (Jemstsa kebele)

Soil erosion is visible for about half of the survey area: 41% of the sampled plots showed visible signs of sheet erosion and 5% showed active rill erosion (Figure 4). One farm experienced gully erosion.

Few sheet erosion signs were observed in the eastern block; however, only 2 farms have established structural soil and water conservation measures: Of the 16 plots experiencing sheet erosion, none of them have soil and water conservation structures in place: Of the plots experiencing gully erosion also none of farmer has established measures to control erosion and runoff. The high presence of soil erosion and the low numbers of soil and water conservation measures should be one of the key-entry points in this water shade (block).

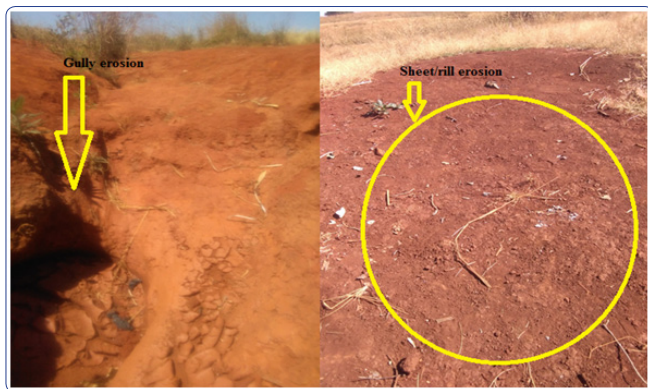
**Figure 5:** A plate showing a sign of soil erosion at western block (Amba 16 kebele)

Soil erosion was visible in almost all sampled plots (92%). The type of erosion is mainly sheet erosion with only one farm showing signs of gully erosion. Figure 5 indicates a visible signs of sheet erosion and gully erosion.

Soil and water conservation is not being practiced in this block. Despite the presence of sheet erosion on 35 farms and steep slopes on several farms, none of the farms in the sample had established contour lines, terraces or other conservation measures to divert runoff and control soil erosion. Therefore, soil and water conservation in association with tree planting should be one of the first activities undertaken in this block. Similar study was also stated. For example, except for the traditional stone bunds in Adis Bodare kebele, no significant replication or adoption effort occurred. In previous studies many site specific socioeconomical and biophysical situations influenced the replication and maintenance of structures [12-16].
